OVERHEAD NETWORK CONDITION ASSESSMENT MANUAL

PREFACE

The Lines Classification Defects Manual has been produced to provide guidance to the Asset Inspector for determining:

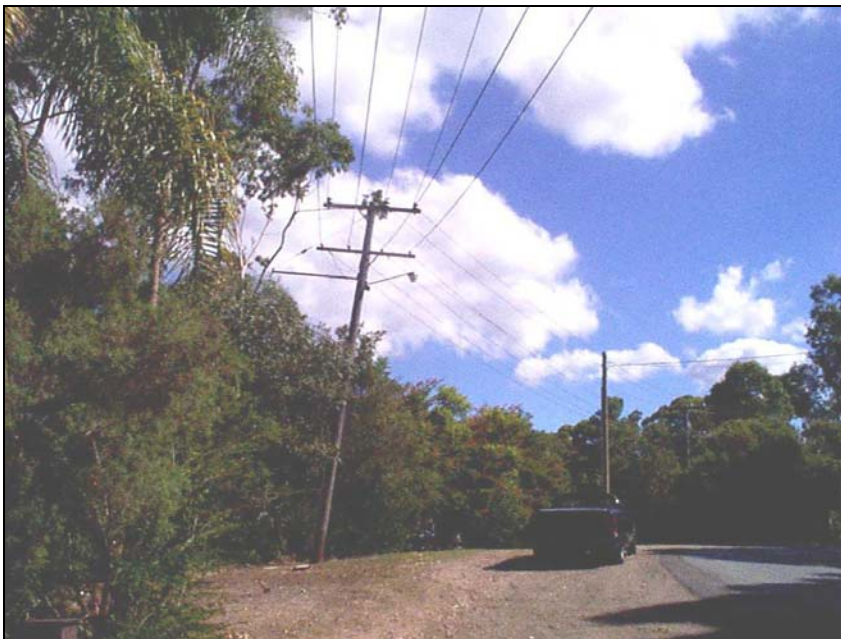
Figure 2.1A – Acceptable Leaning pole. Check condition of pole base below ground. Note use of back-stay to stabilise pole.

Check condition of back stay anchor points.

In this situation pole is acceptable for continued use due to back stay and condition of pole base below ground.

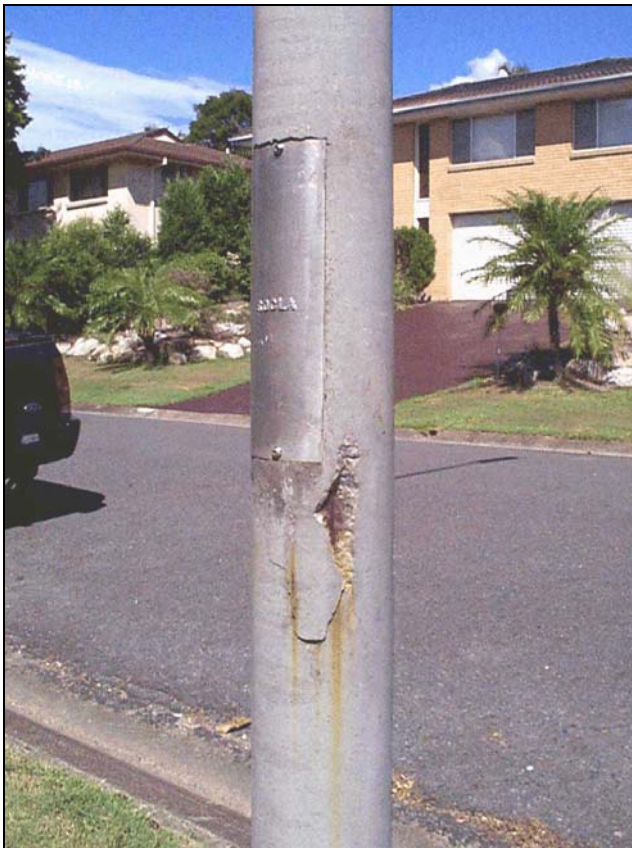
Figure 2.2A – Unacceptable.

Significant cracking of concrete and rust staining of concrete is evident. These conditions indicate steel re-enforcing is rusting or susceptible to rust. A potential loss of strength is quite likely.

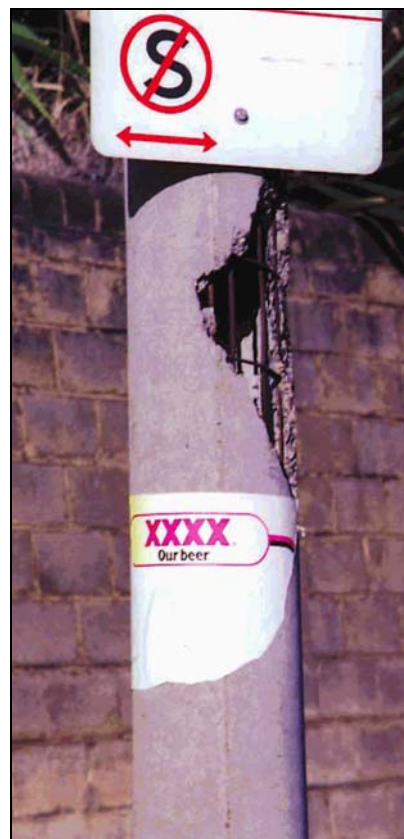
Figure 2.2B – Unacceptable.

It can be observed that large pieces of concrete have broken off exposing steel reinforcing. This will promote rusting of the steel re-enforcing.

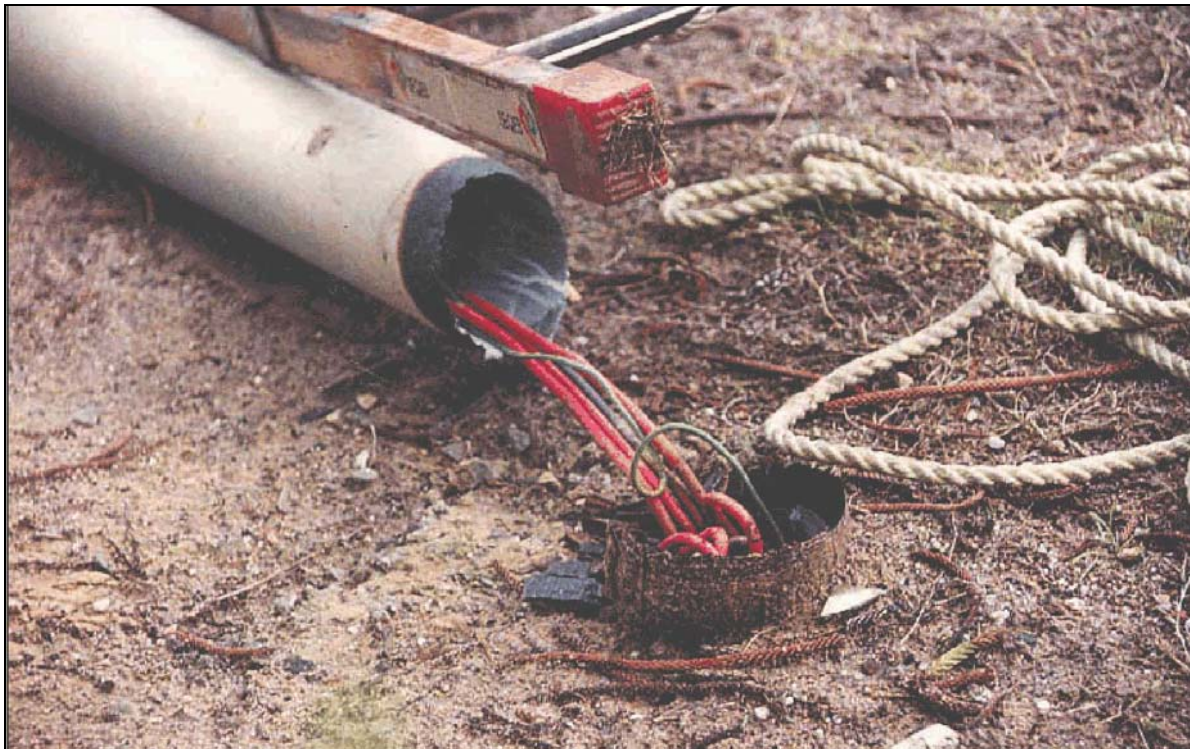
Figure 2.3A – Unacceptable.

Sandy and salt contaminated soil contributed to rust promotion below groundline and above concrete footing.

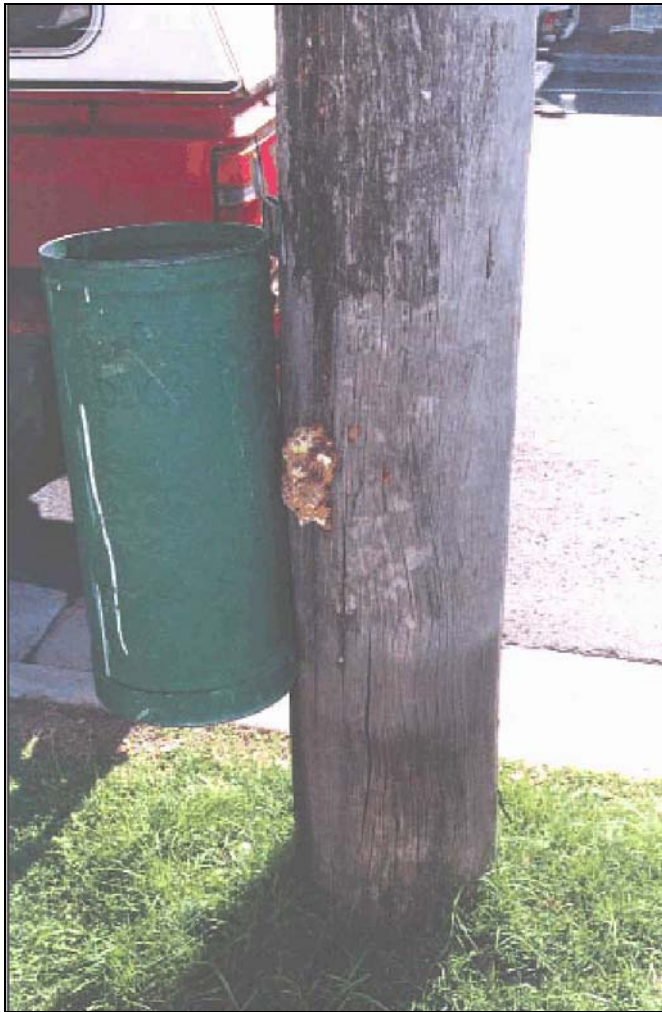
Figure – 2.4.1B – Unacceptable
External Indication.

Hard, crusty brown fungal growth external to the pole, growing out of pole cracks located about one metre above ground level. This is a mature fungal fruiting body, usually associated with internal brown rot.

Note: the extent of cross sectional area affected by the brown rot. An area this size will severely weaken the strength of the pole and is considered unacceptable.

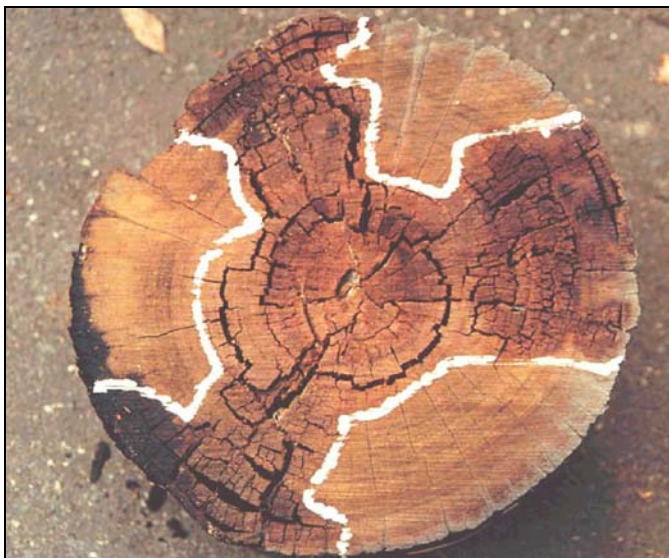
Figure 2.4.1D – Unacceptable.
Internal Condition.

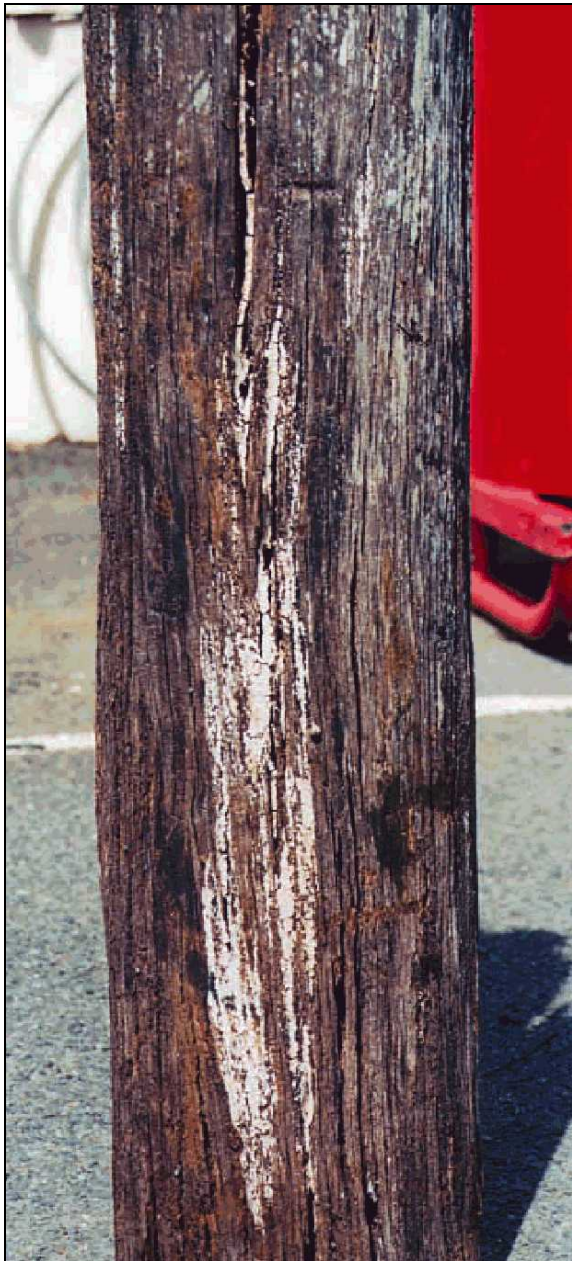
Figure 2.4.1F – Unacceptable
External Condition.

White Rot is identifiable by a white, flat growth on the pole surface and in the checks. It is located in long patches above ground.

Amount of growth indicates that rot is at an advanced stage.

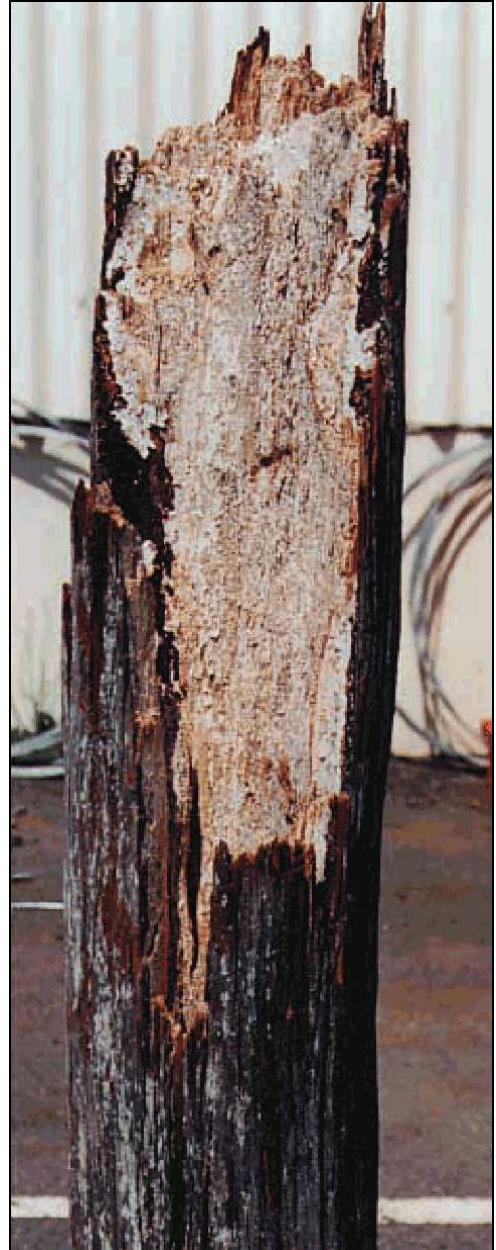
Figure 2.4.1G – Unacceptable
Internal Condition.

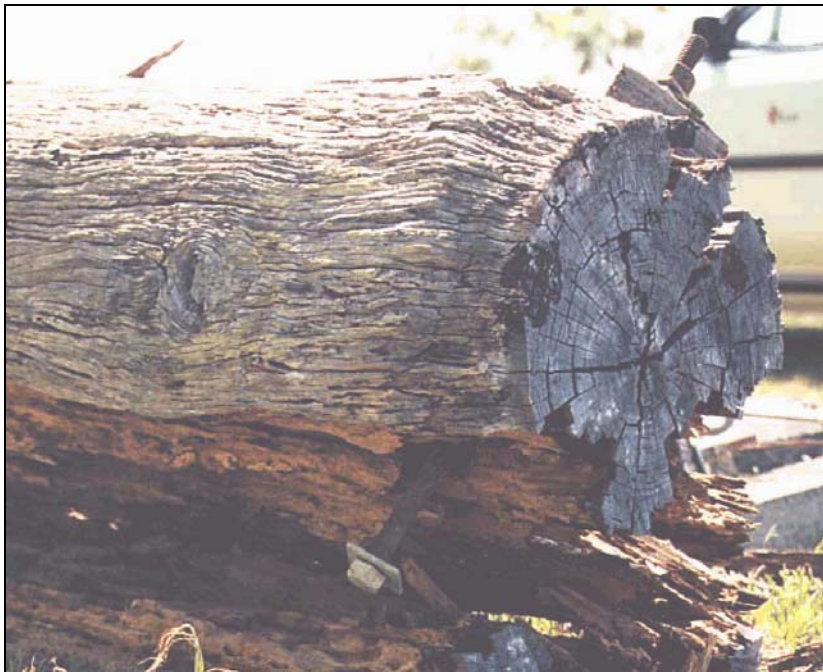
Figure 2.4.1I – Unacceptable.
Internal Condition.

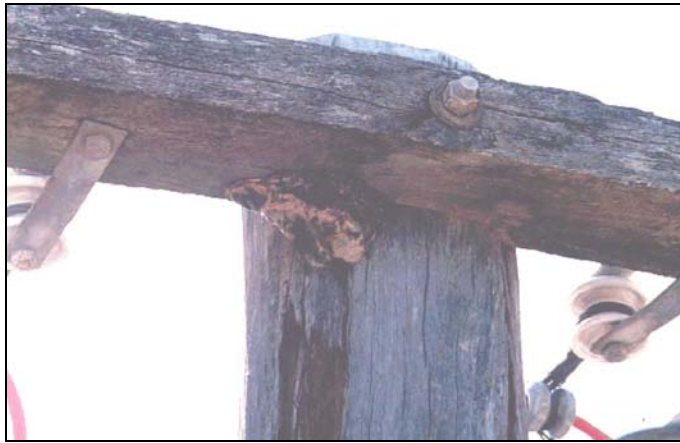
A hard, crusty brown growth with a 'velvet' surface and irregular shape can be observed external to the pole, growing out of crossarm and pole simultaneously is an indication of internal white rot.

Figure 2.4.1J – Unacceptable.
External Indications.

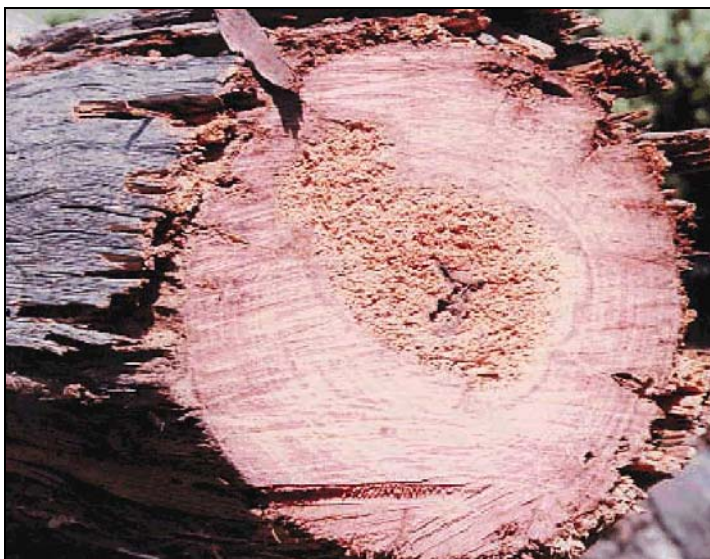
Figure 2.4.1K – Unacceptable.
Internal Condition.

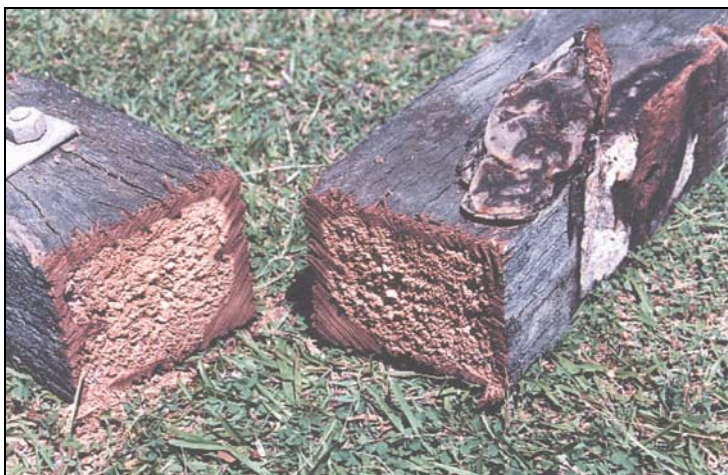
Figure 2.4.1L – Unacceptable.
X-Arm Internal Condition.

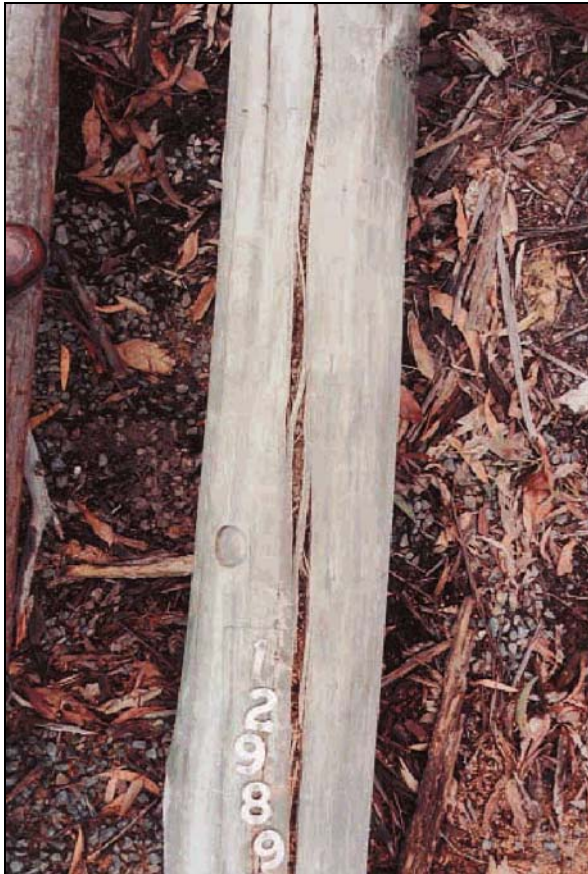
Note the long vertical split running down the pole. This was filled with mud. This could indicate the presence of termites within the pole.

Termites fill in cracks to seal the internal chamber from the outside environment. This allows unimpeded internal destruction of the pole.

Figure 2.4.2A – Unacceptable.
External Indications.

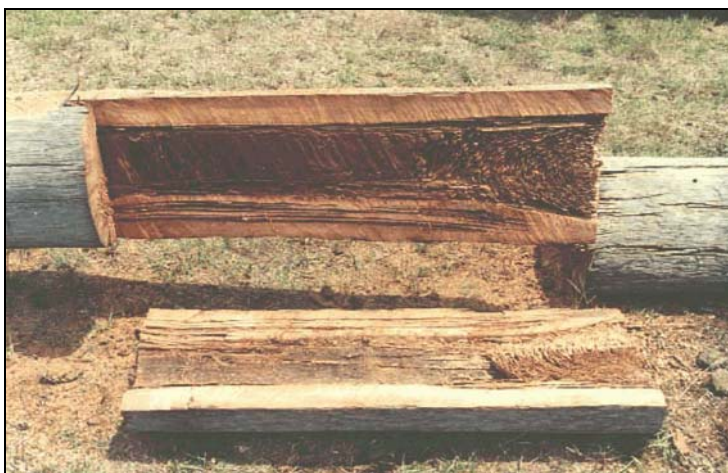
Note: the amount of cross-sectional area destroyed by termites. This would have severely weakened the pole.

Figure 2.5.2D – Unacceptable.
Internal Condition.

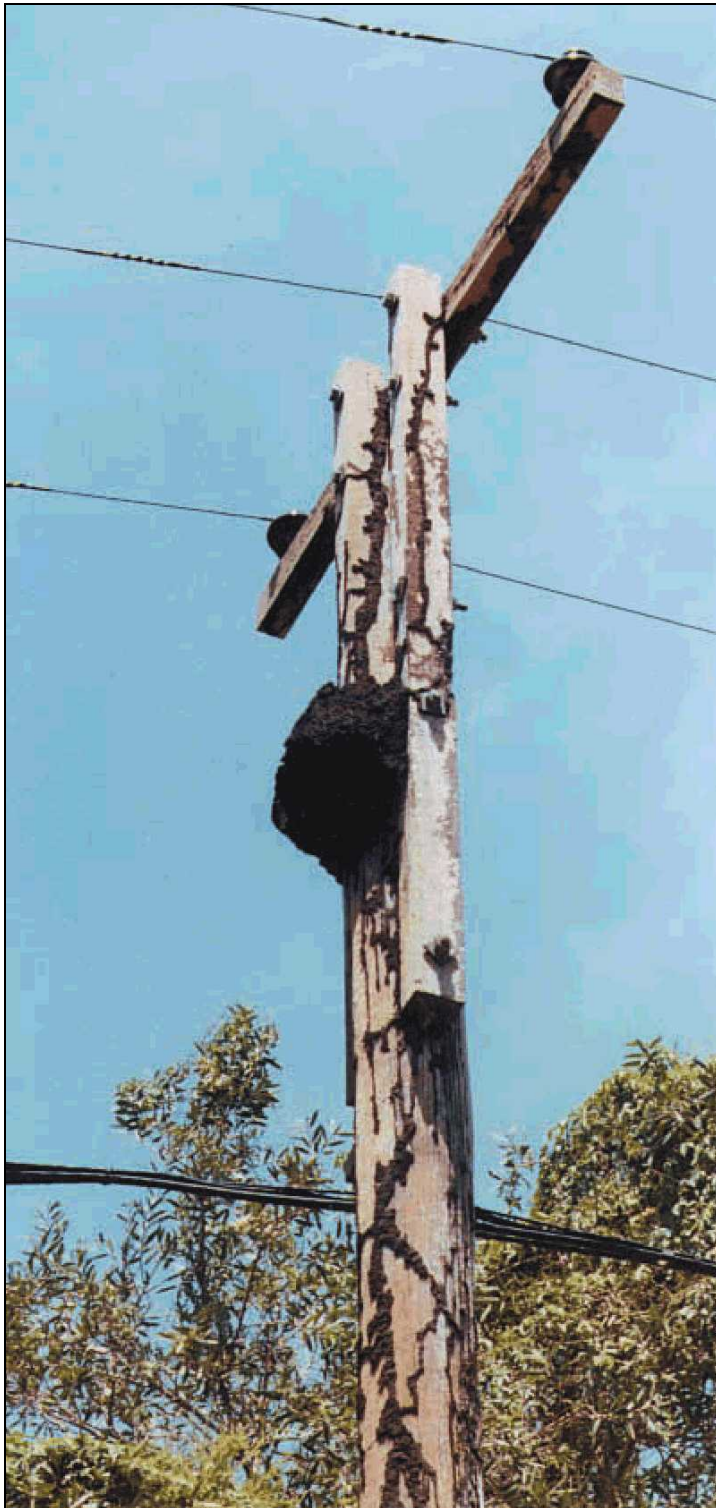
Figure 2.4.2F – Unacceptable.
External Indications.

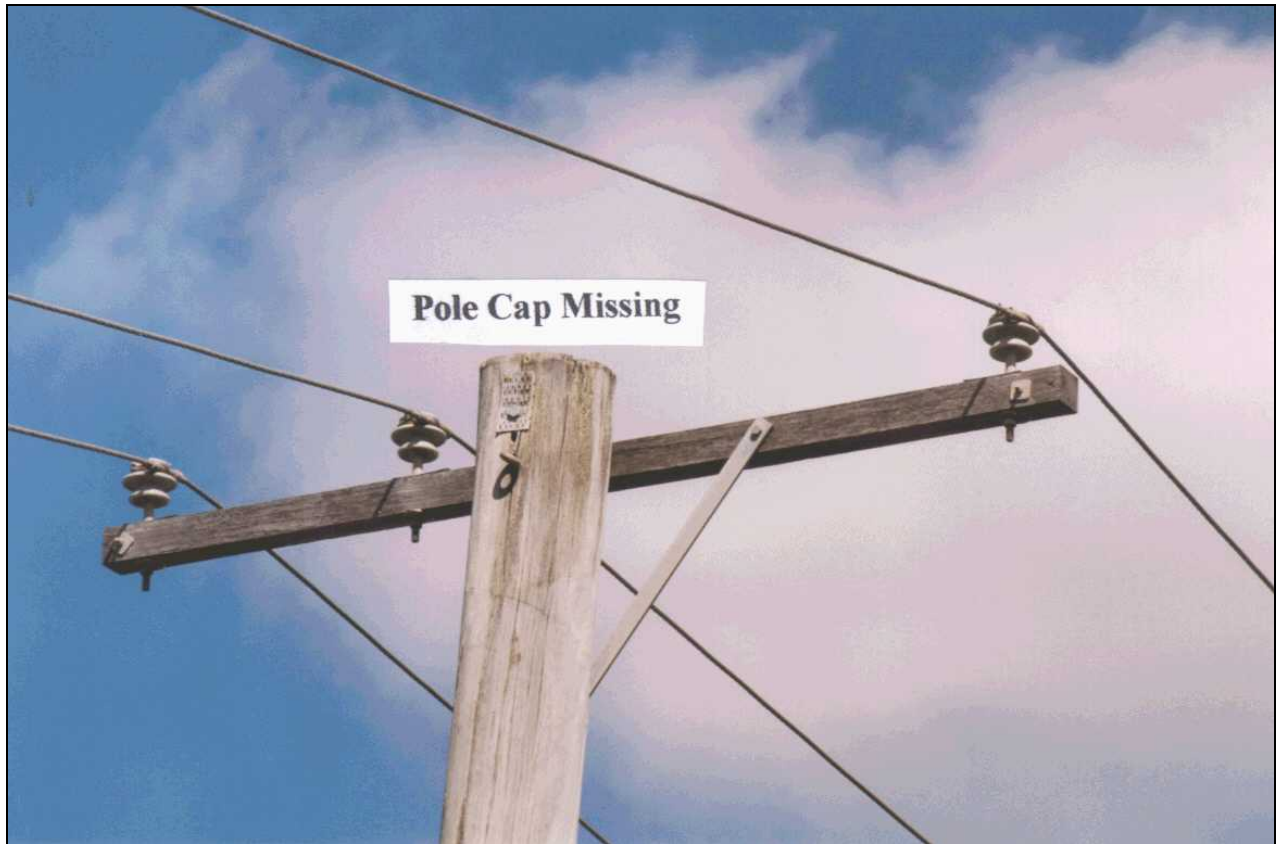
Figure 2.4.3A – Unacceptable.
Missing Pole Cap.

If live line patrolling, replace cap.

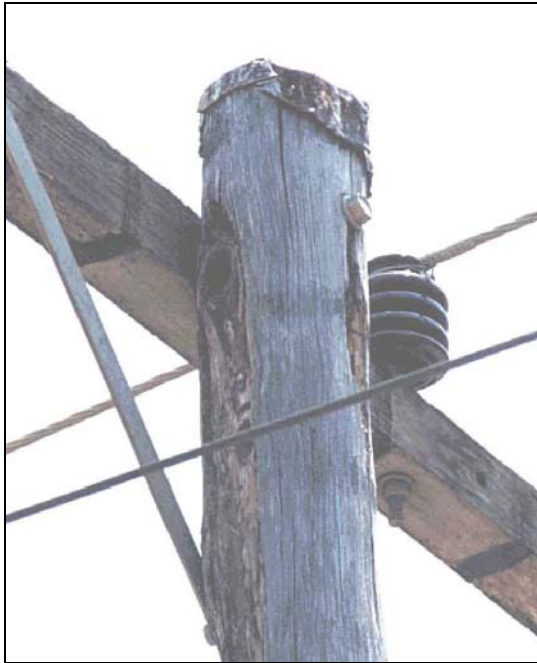
Knot hole and splitting associated with the king bolt. This allows ingress of moisture into the pole. This may promote the growth of fungal decay.

Figure 2.4.4A – Unacceptable.
External Indication

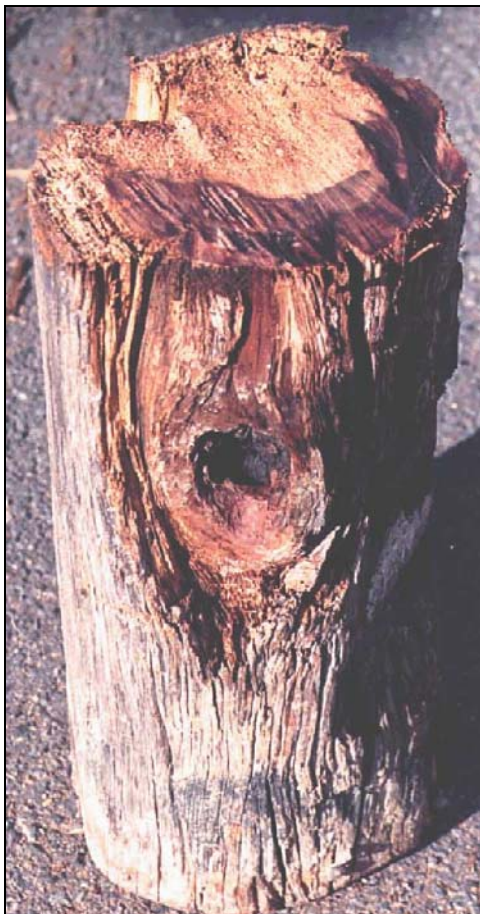
Figure 2.4.4B Unacceptable.
Internal Condition

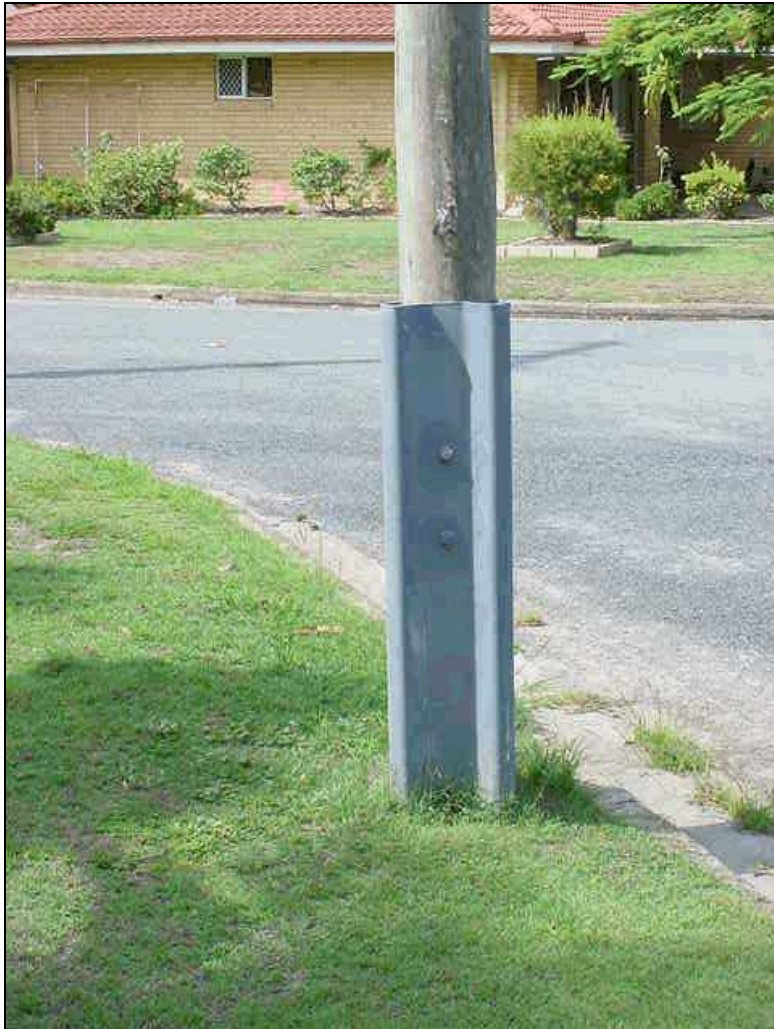
Figure 2.4.5A – Acceptable.
No rust or deterioration present.

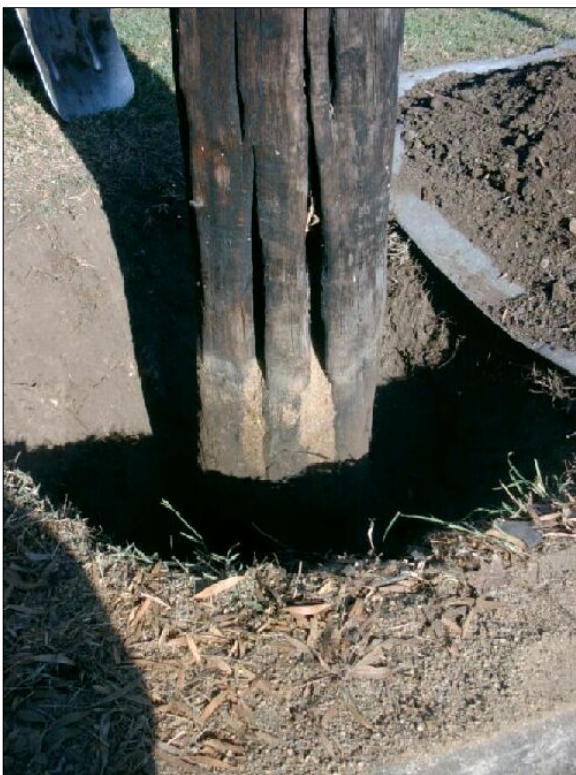
Figure 2.5G – Conditionally acceptable.
Large splits due to star shrinkage but no rot present. Acceptable when splits occur in the neutral axis of the pole.

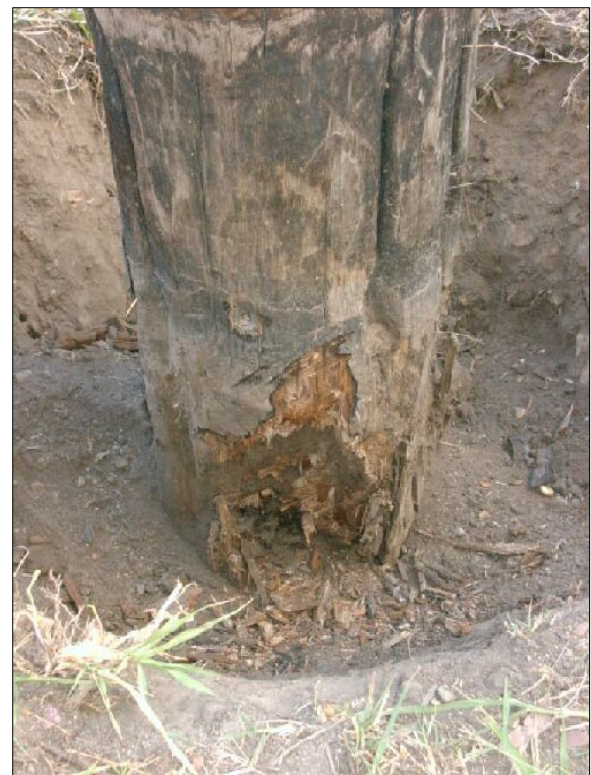
Figure 2.5H – Conditionally acceptable.
External rot present. Acceptable if sound wood provides sufficient strength for the pole loading (determined by tablet) – External rot treatment required.

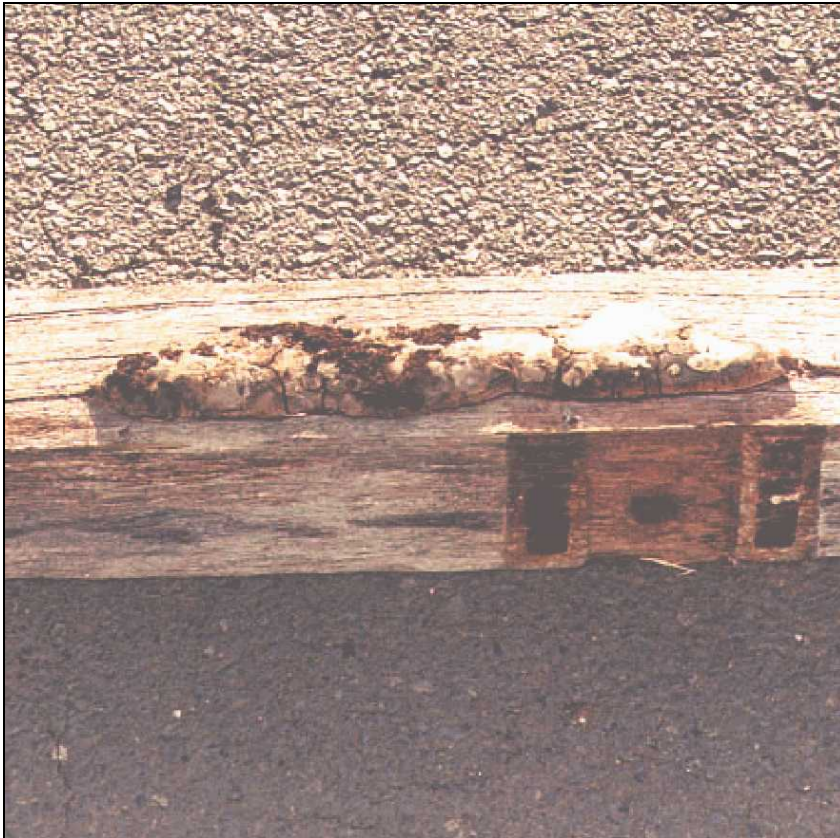
Figure 3.2A – Unacceptable.
White Rot External Indication.

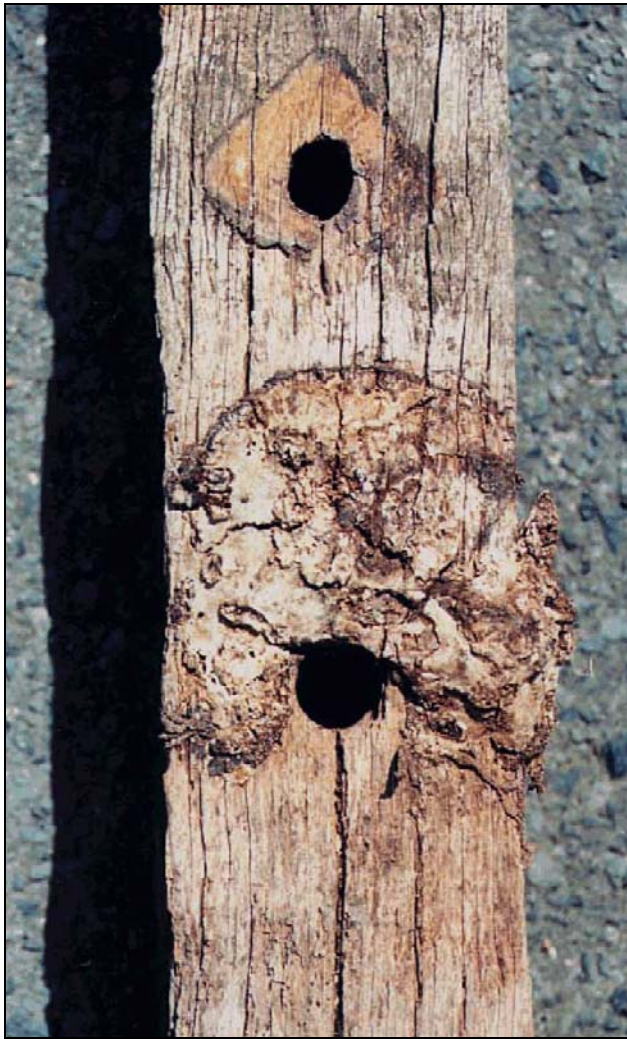
Figure 3.2C – Unacceptable.
X-Arm Failure External Indication.

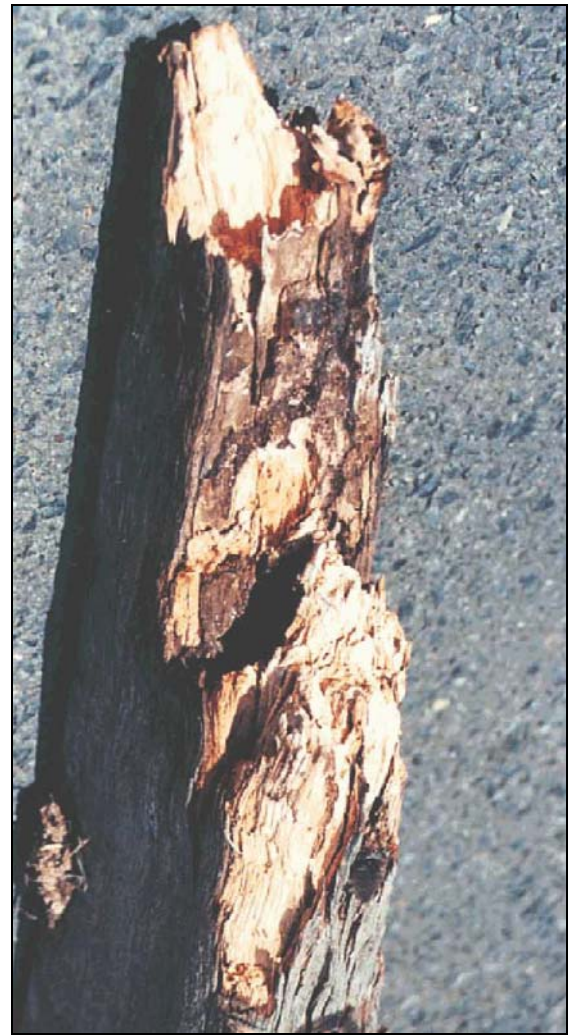
Figure 3.2D – Unacceptable.
X-Arm Failure Internal Condition.

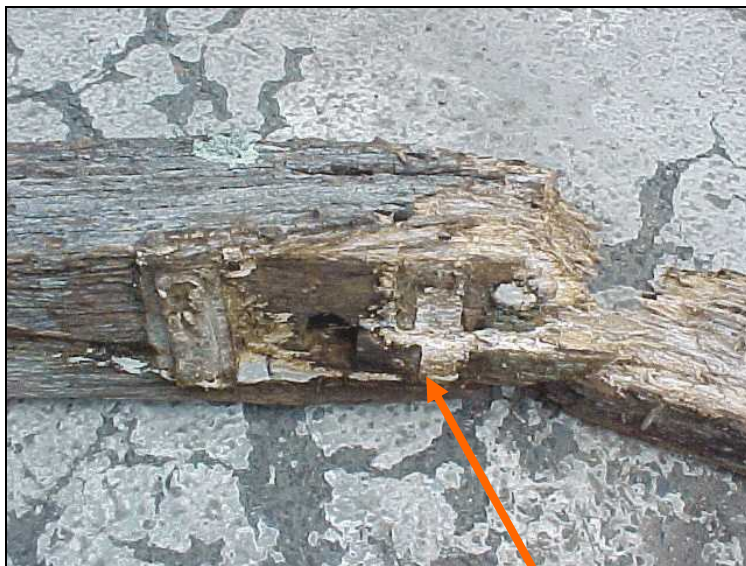
Figure 3.2E – Unacceptable. X-arm failure due to White Rot.

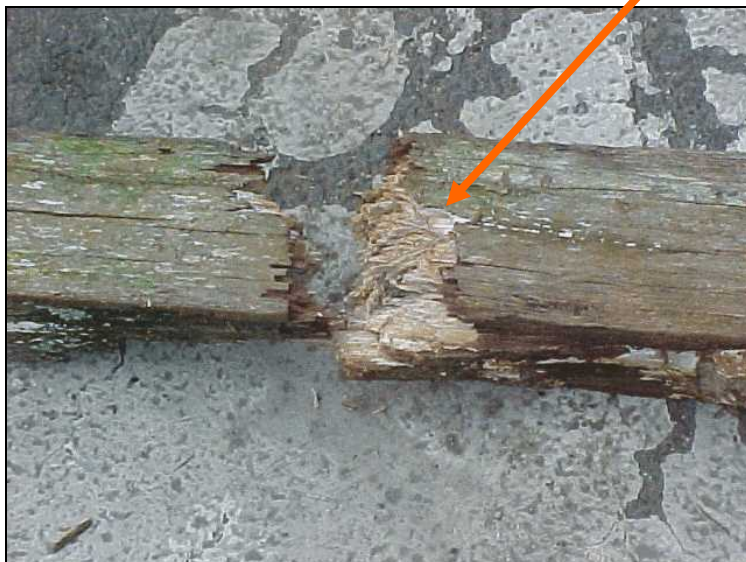
Figure 3.2G – Unacceptable. X-arm failure due to White Rot.

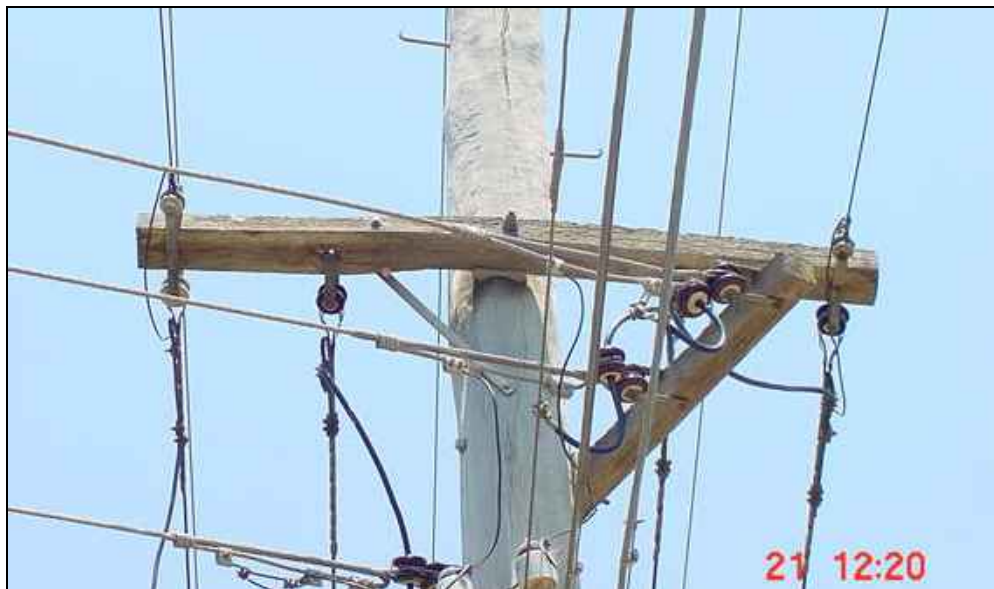
Figure 3.2H – Unacceptable.

Note: the light coming through the hole, and the buckling of the X-arm.

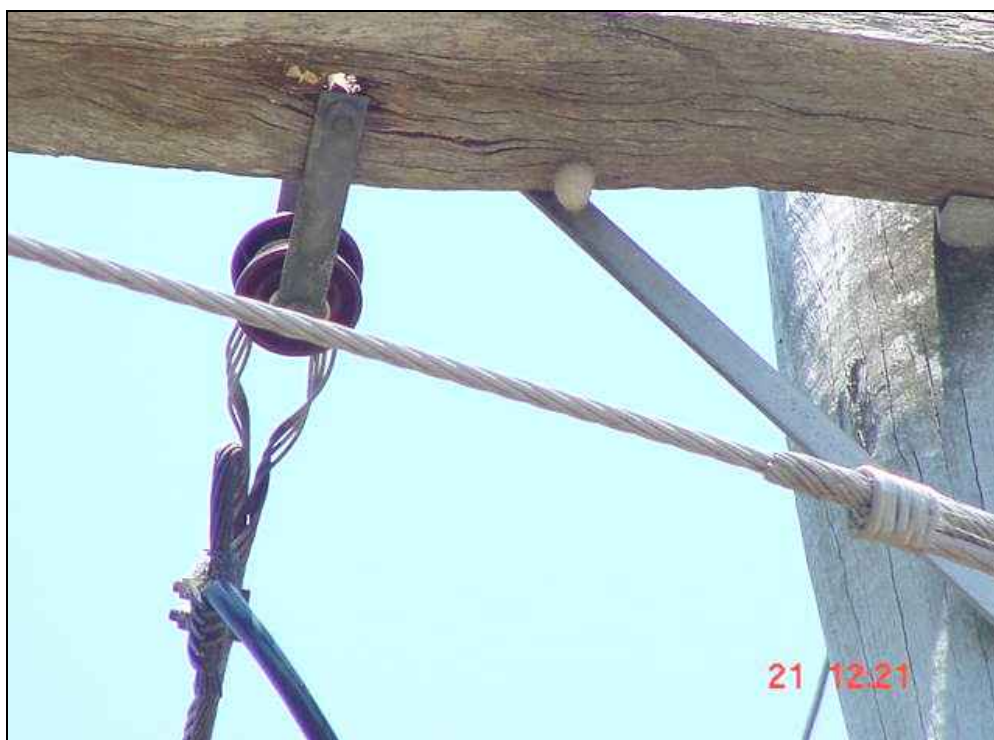
Figure 3.2J – Unacceptable.

Loose shackle due to white rot.

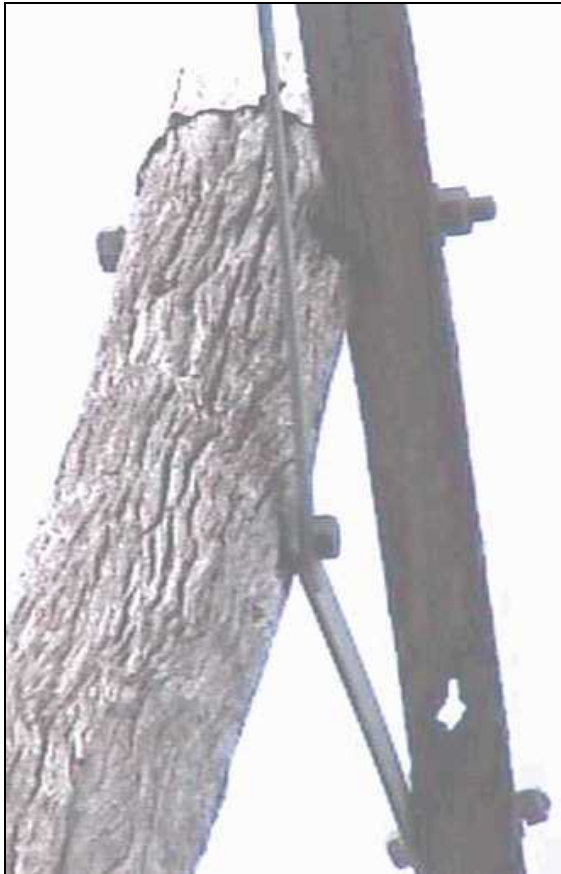
Figure 3.4A – Acceptable.
Hole in X-Arm.

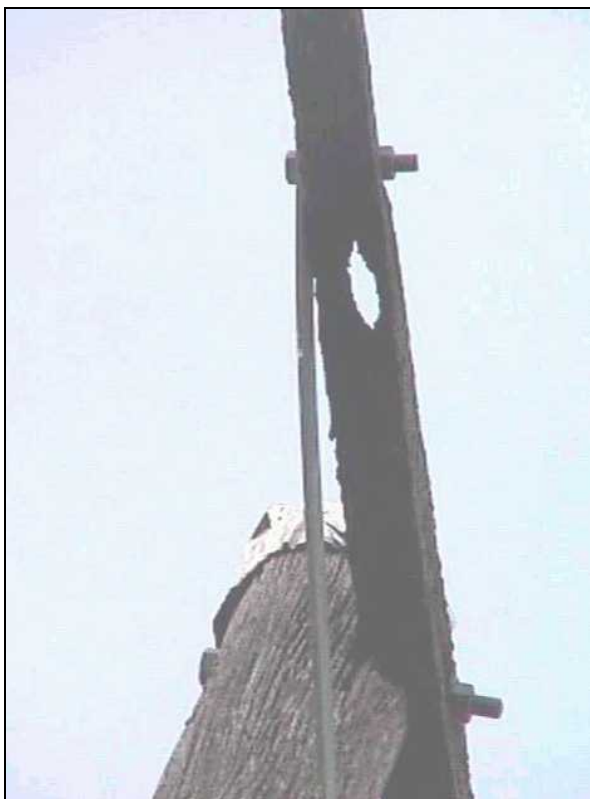
Figure 3.4B – Acceptable.
Hole in X-Arm

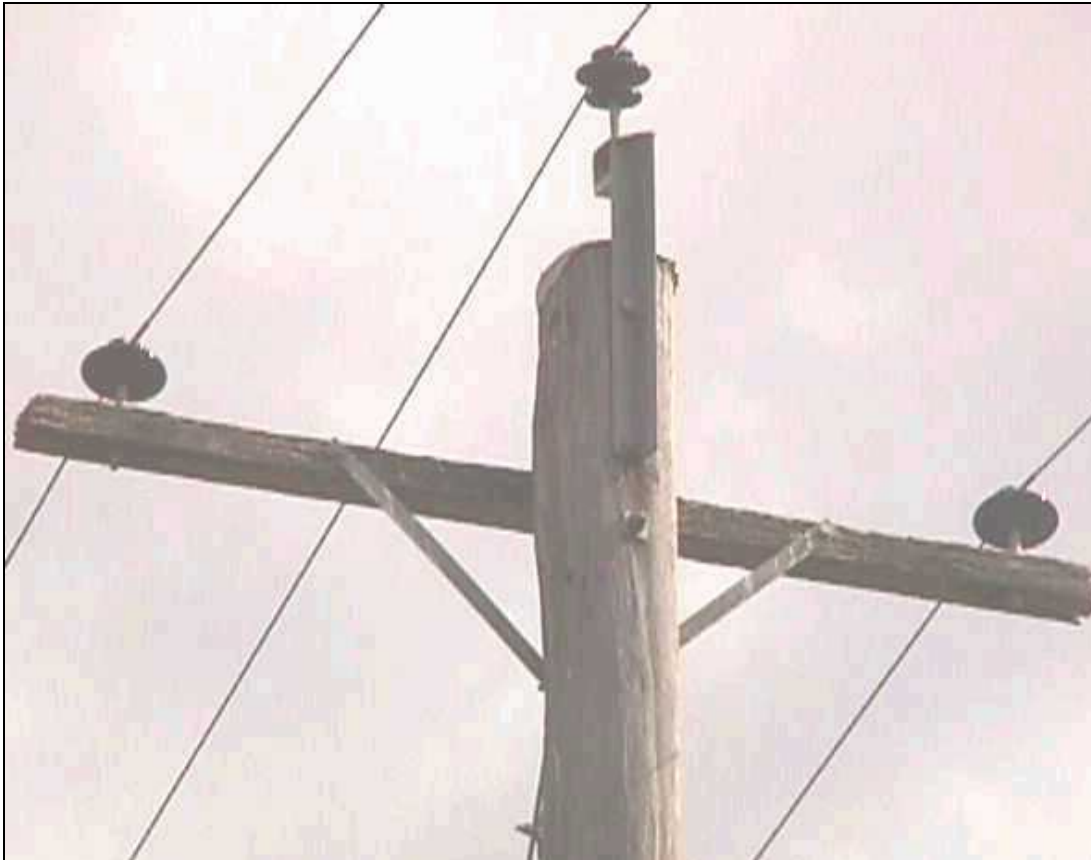
Figure 3.5A – Acceptable.

Weathered x-arm may not mean it is unservicable. If no rot is found and it is still structurally sound, the x-arm is acceptable for continued service

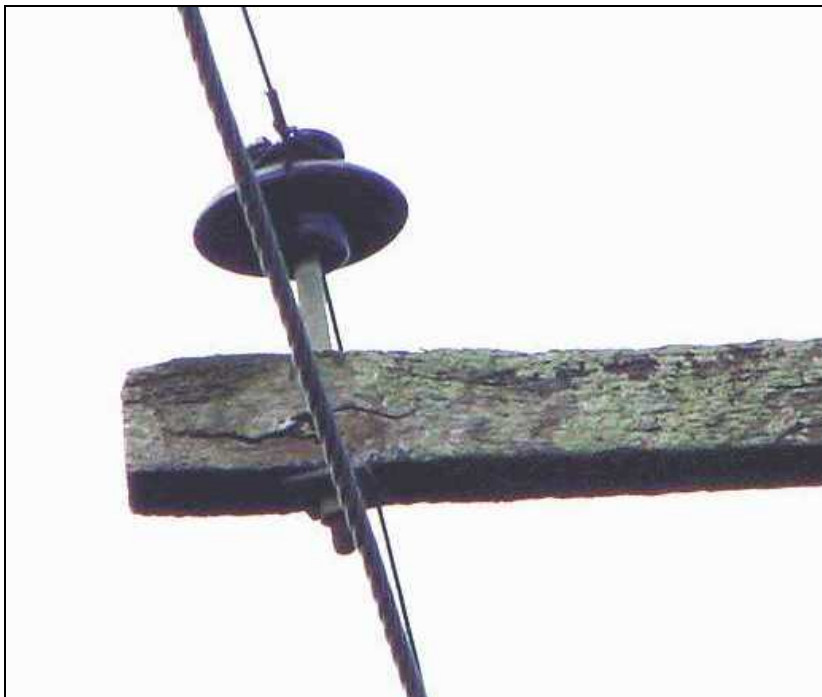
Figure 3.5B – Acceptable

Note: although Lichen is visible on x-arm, when x-arm was checked by live line team no rot was found.

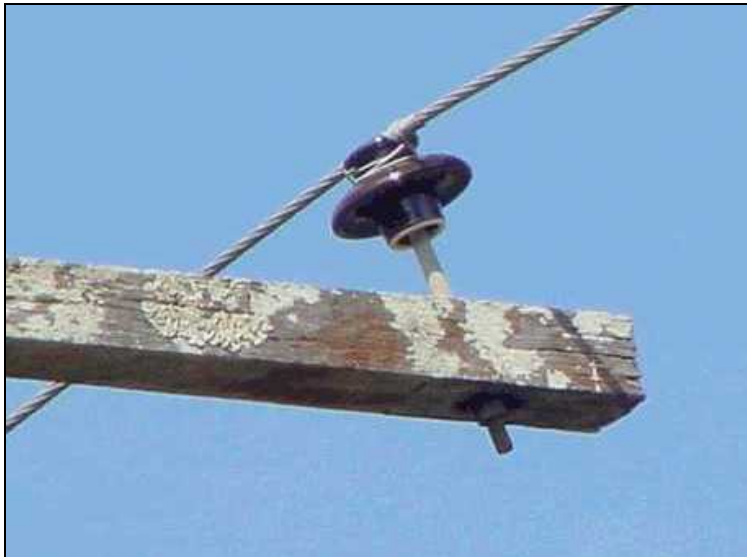
Figure 3.5C – Acceptable Weathered X-Arm.

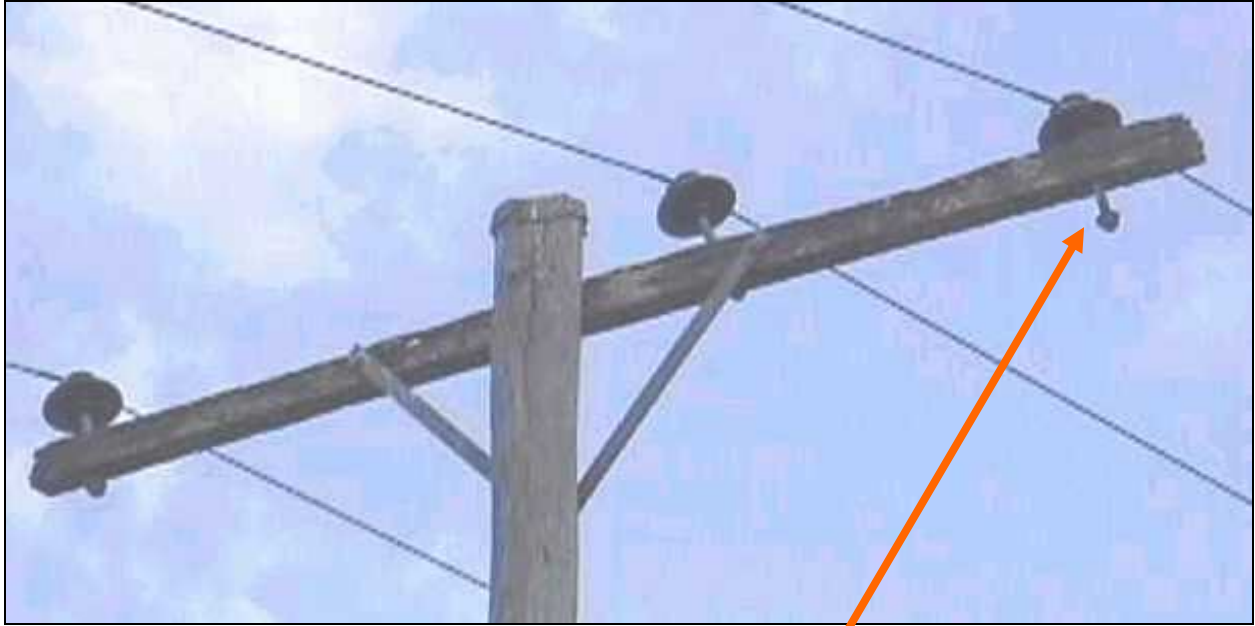
Figure 3.6A – Acceptable.
Pin dropped through x-arm. Not critical due to wood x-arm.
Check X-arm very carefully for signs of rot. If rot present report.

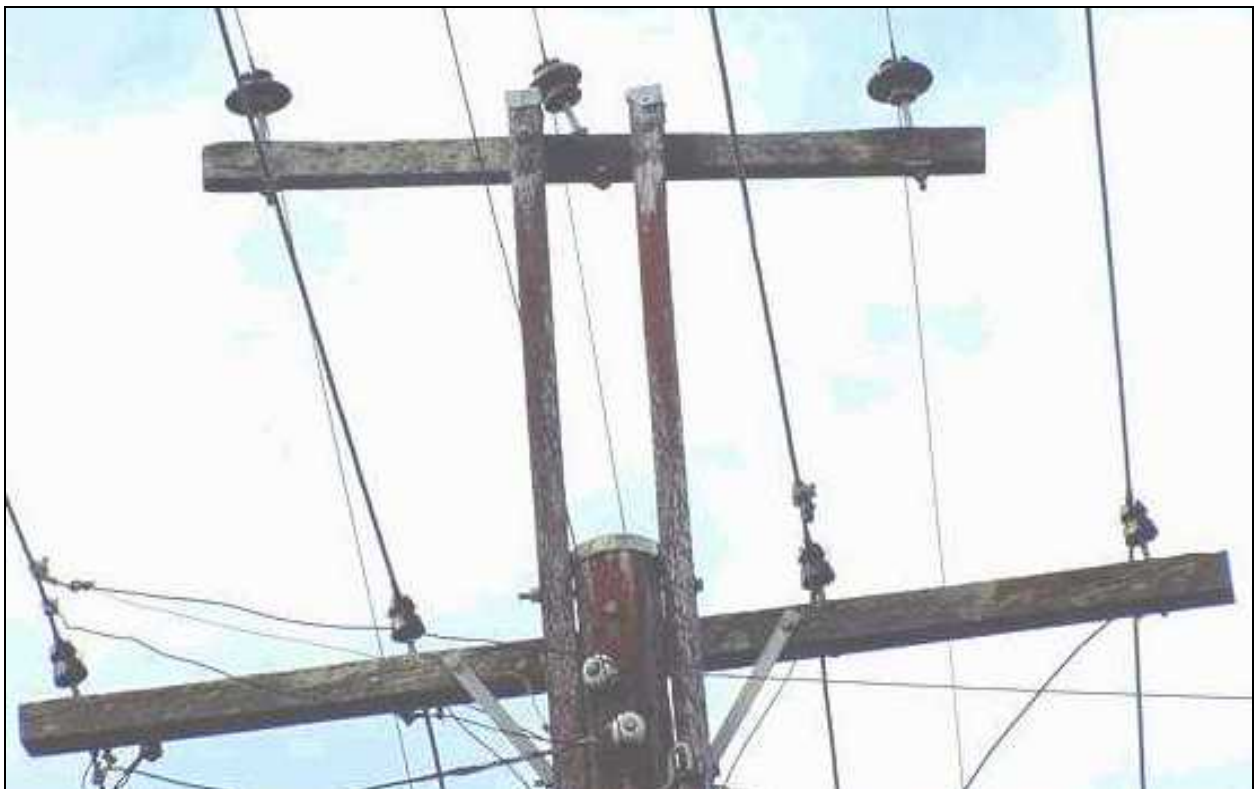
Figure 3.6B – Acceptable.
Insulator leaning. Not critical due to wood x-arm.

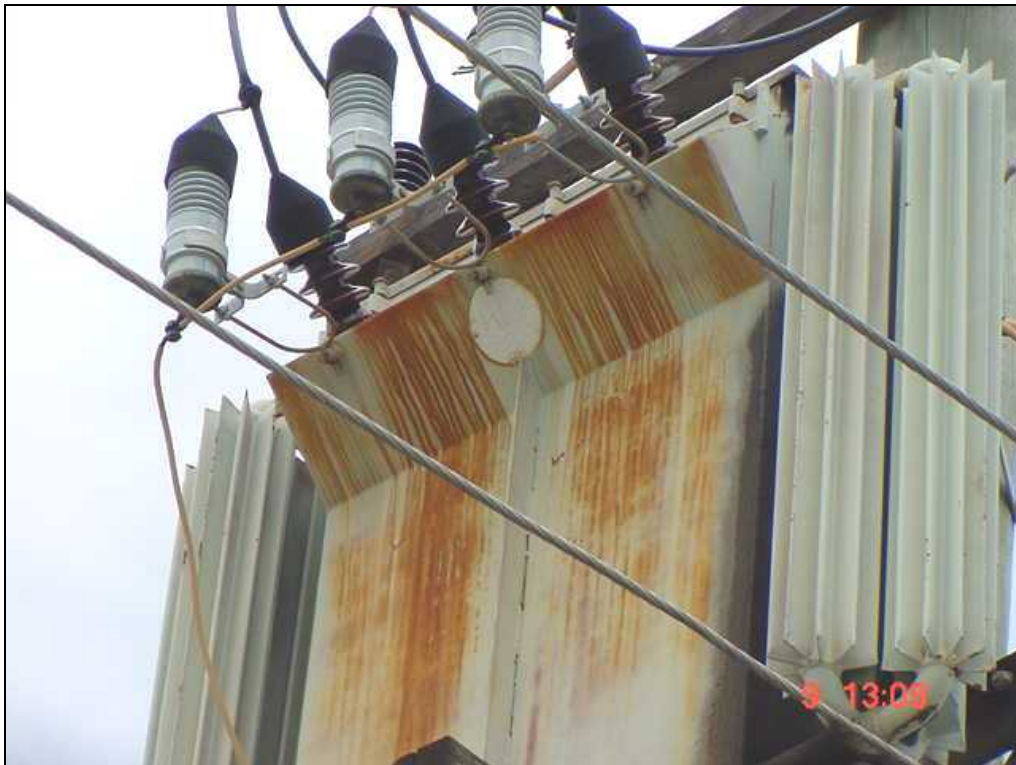
Figure 4.1A – Acceptable.
Surface rust on transformer. Unlikely to result in transformer failing.

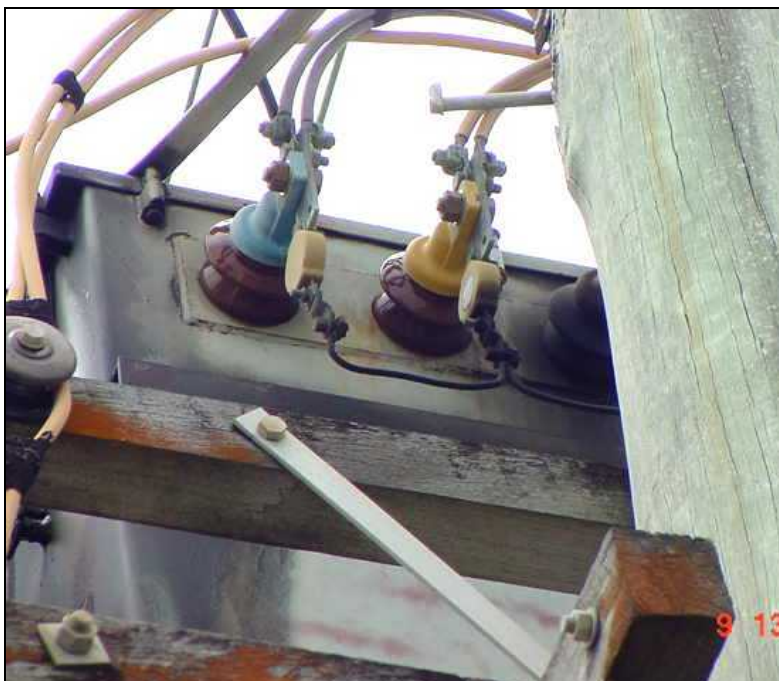
Figure 4.1D – Acceptable.
Old / Inactive oil leak from lid of transformer.
