OVERHEAD NETWORK CONDITION ASSESSMENT MANUAL

PREFACE

The Lines Classification Defects Manual has been produced to provide guidance to the Asset Inspector for determining:

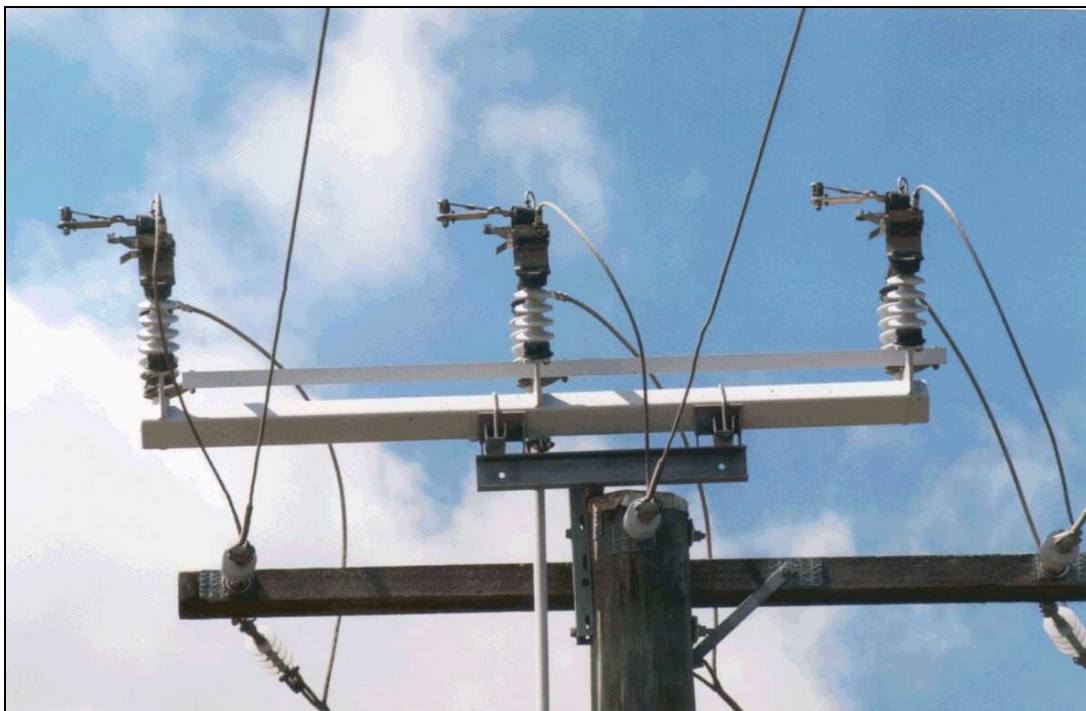
Figure 4.3A – Acceptable.

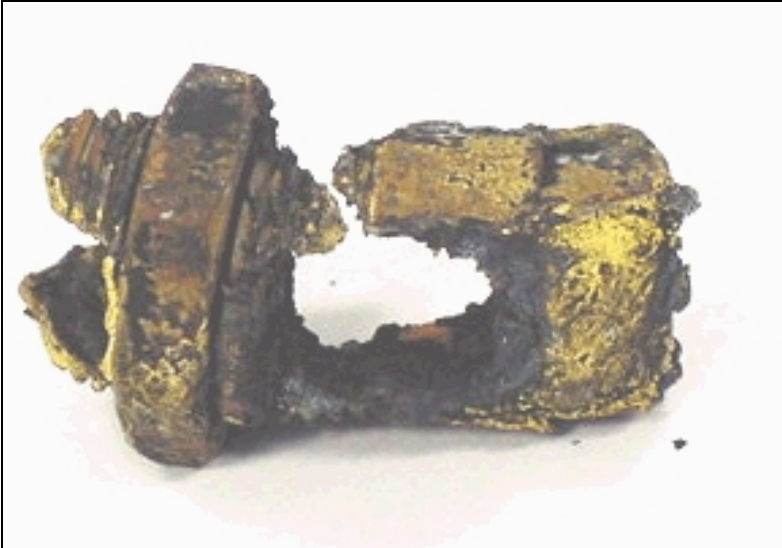
Figure 5.2A – Unacceptable.

Note how clamp has burnt through allowing mains or bridging to fall.

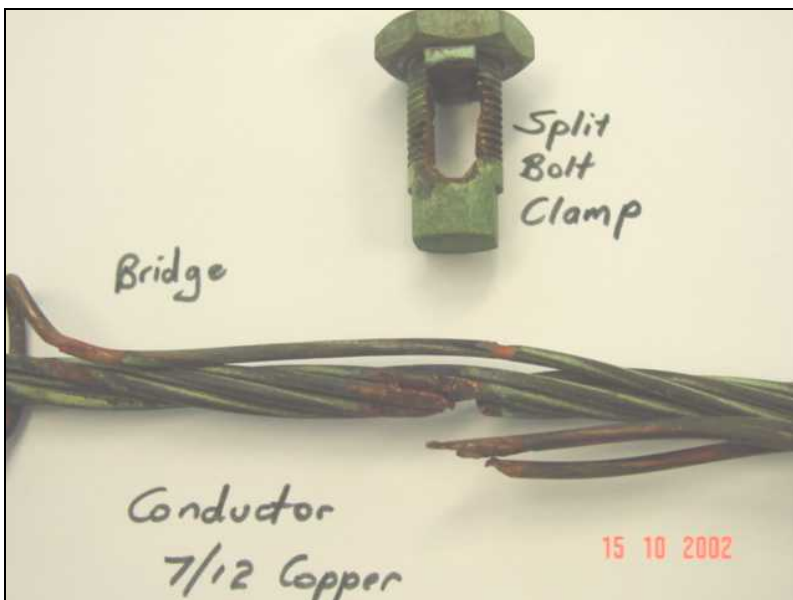
Figure 5.2.B – Damage to Conductor from Loose Split Bolt Clamp.

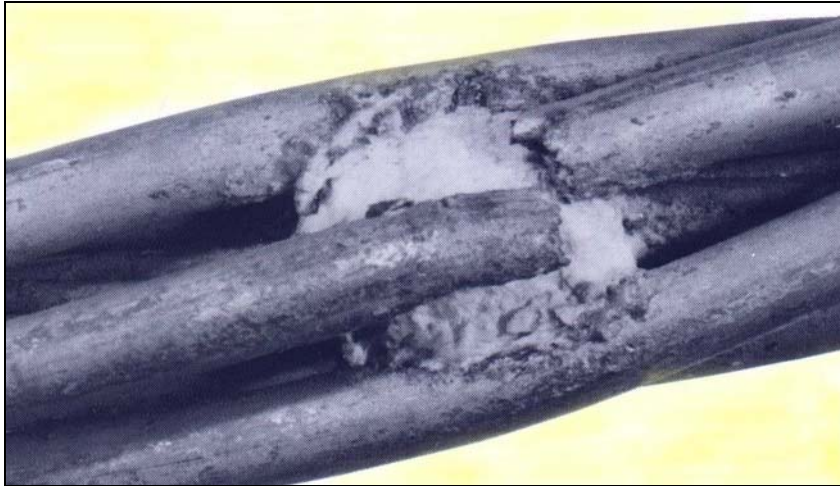
Figure 6.F – Unacceptable.
Advanced corrosion of ACSR conductor.

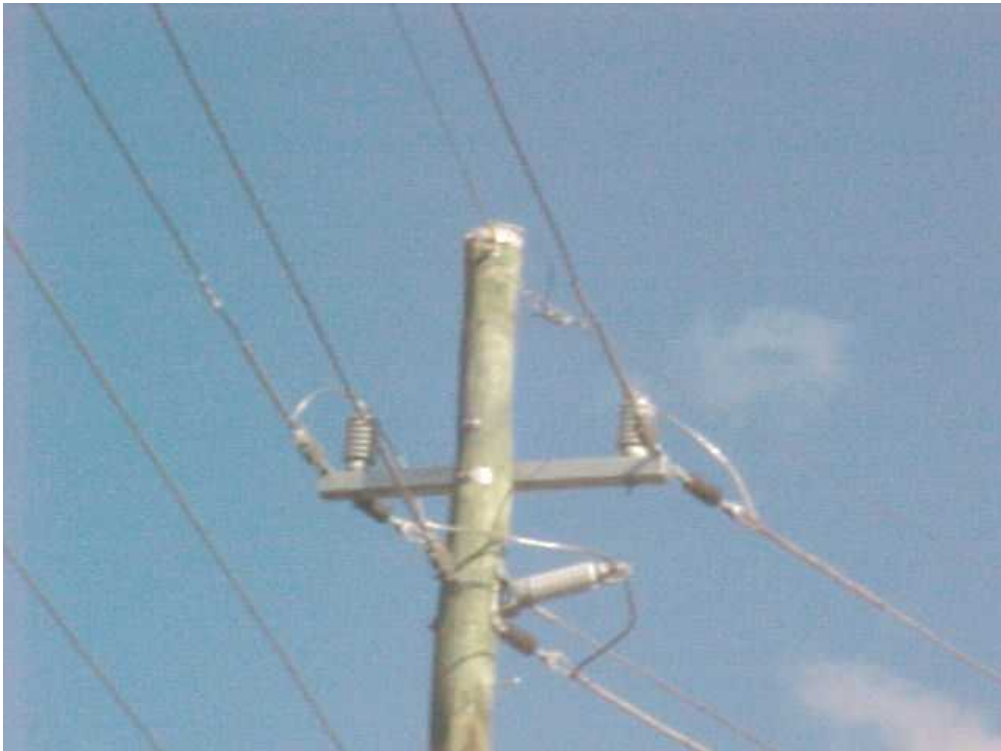
Figure 8.1C – 33kV electrical clearances between steel crossarm and conductor
May be compromised by birds. Bird proofing required (Vertical Shackle).

- Long, slack spans where conductor clashing is noted
- Underslung suspensions (with two phases on one side) where conductor clashing is noted
- Pin constructions with spans greater than 130 m
- Suspension constructions with spans greater than 100 m remote from a substation or 80m near a substation
- Transition from the old to new 33kV wishbone constructions (Figure 8.1A)
- Transitions from 33kV vertical delta to flat constructions (Figure 8.1B)
- Where statutory , phase to phase or phase to earth clearances are compromised (Figure 8.1C)

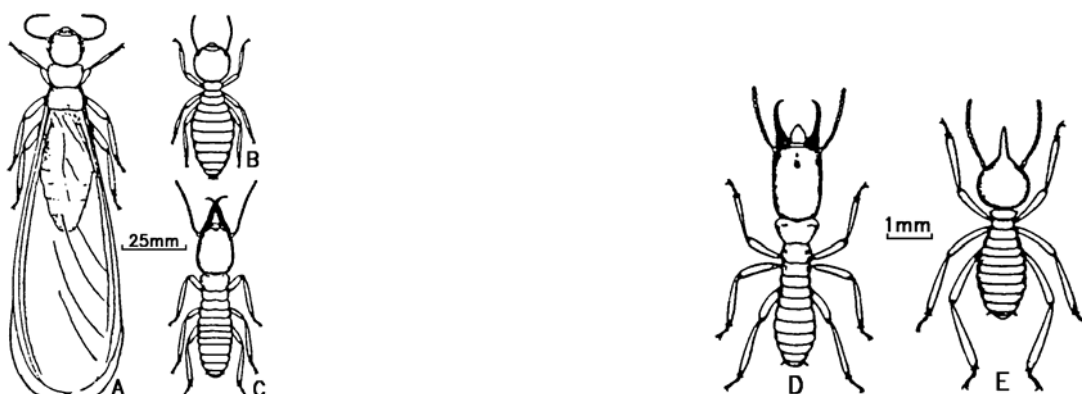
Figure D5 - Castes of Termites. A: alate B: worker C: soldier D: mandibulate soldier E: nasute soldier

The termites which concern you are all soil-dwelling forms and all are social insects, living in colonies of many millions of individuals in some cases. Each colony contains workers, soldiers, juvenile forms and at least one pair of reproductives known as the king and queen. At certain times each year winged forms or alates will be present. The workers constitute the great mass of individuals and are wingless, sterile and blind. The soldiers are also wingless, sterile and blind but have strongly chitinated and darkened heads. They also possess a pair of strong mandibles or a prominent snout and are particularly important in the identification of species as well as in the defence of the colony. The king alters little during his lifetime while the queen frequently develops into a grotesque egg-laying machine capable of producing in excess of 2000 eggs per day. Such a queen is known as a **physogastric queen**. In some termite species supplementary reproductives or **neotenics** are produced should the original queen die or if her reproductive capacity decreases. In other species neotenics may in fact be first-form queens that is, the original source of eggs in a colony (see Figure D5).
